Safety Inspection Report

Annual Inspection

Highfield Amenity Area

Groby Parish Council

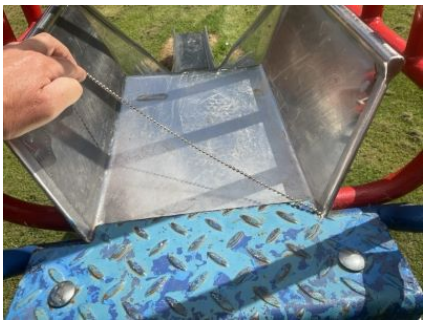
There is a toggle entrapment.

5

No reasonably practicable action is identified.
