Safety Inspection Report

Annual Inspection

Queen Elizabeth II Park

06 May 2026

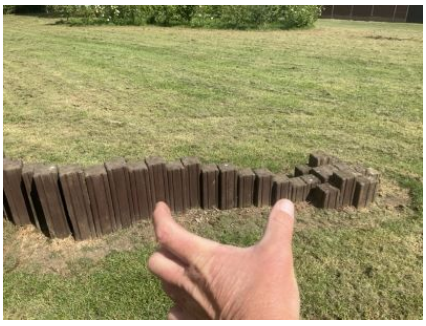
Agility - Stepping Logs

Loose in ground.

Slight movement in the foundations. Monitor.

6

Monitor.
