Safety Inspection Report

Annual Inspection

Quarry Park - MUGA

Groby Parish Council

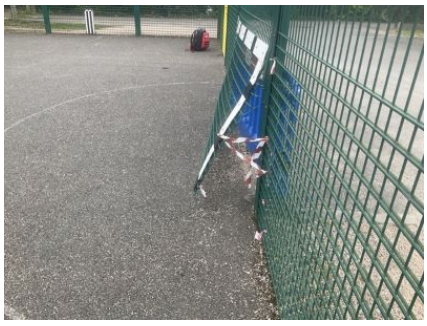
Hockey Goals

Item is damaged.

Damaged panel protruding in to the area of play. Repair or make safe.

12

Repair.
