Safety Inspection Report

Annual Inspection

Quarry Park - Play Area (Enclosed)

Groby Parish Council

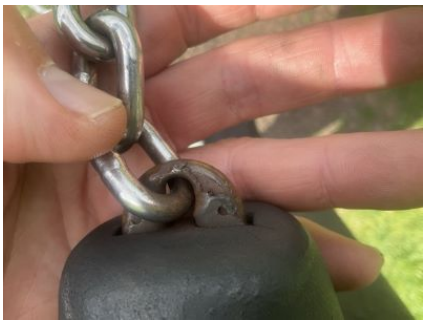
Some chain wear.

Replace worn seat connectors.

Monitor for further deterioration and replace before 40% wear.
